Mr. Robert Bowden, Chief
Spill Response Section
Environmental Protection Agency
536 South Clark Street
Chicago, IL 60604

20 October 1983
TAT-5-8310-05

On 14 and 17 October 1983, officers from the Illinois Department of Law Enforcement, Division of State Police, and TAT member Stofferahn conducted inspections of six sites in the Chicago area being used to store cyanide contaminated film chips. These visits were made to assess the structural integrity of the semi-trailer vans which are holding the waste.

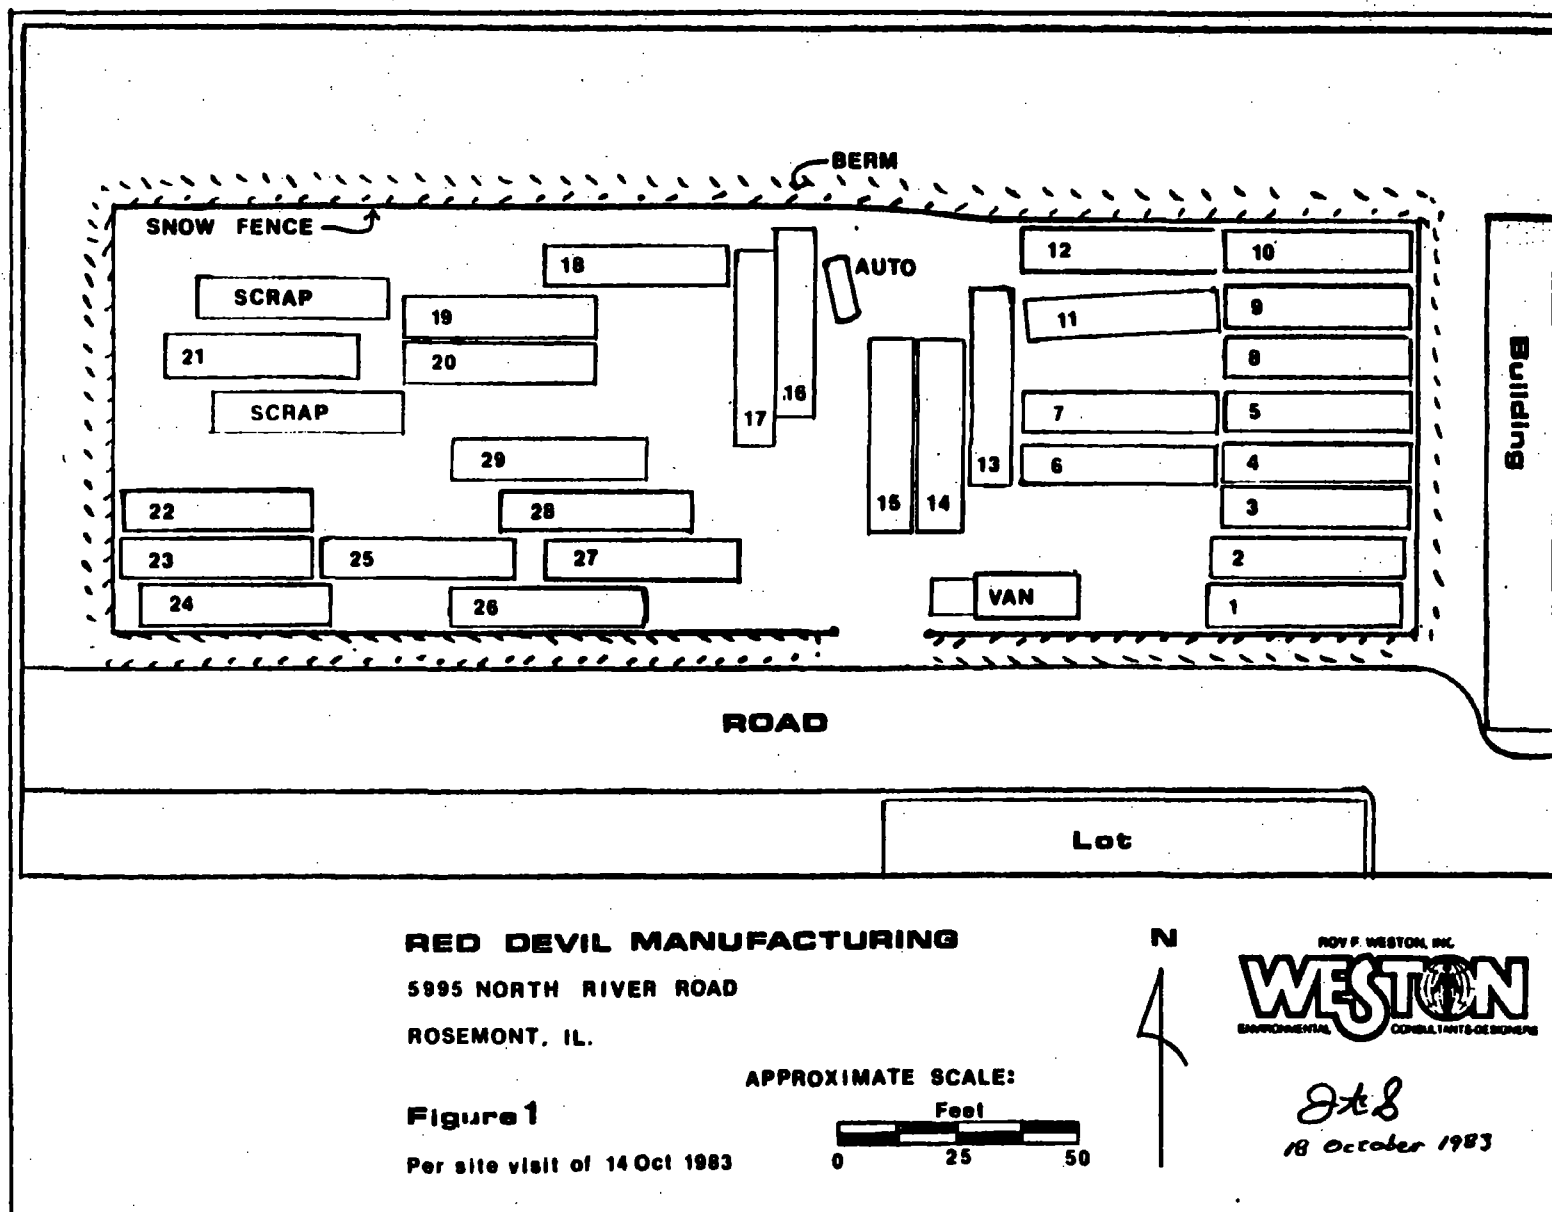
On 14 October 1983, TAT member Stofferahn met with Troopers Koch and Delacy at District Three Headquarters of the Illinois State Police, 4051 N. Harlem Avenue, Chicago. After a brief explanation as to what the site assessments were to involve, the troopers and TAT proceeded to the Red Devil Manufacturing facility at 5995 North River Road, Rosemont, Illinois (Figure 1). Twenty-nine trailers were numbered with spray paint and categorized. The results of the assessment are given in Table 1. Trailer three was found to contain no waste chips. All other trailers were noted to be leaking or seeping leachate to some extent. Five trailers, numbers 13, 15, 18, 27 and 28, were recommended by the officers to be offloaded. The trailers are confined to a small bermed area, and little room to access the majority of the trailers exists. A small asphalt lot was noted across the street from the site which could potentially be used to temporarily store the structurally sound units while the others are being repaired or off-loaded. No information as to the owner of this lot was available at this time.

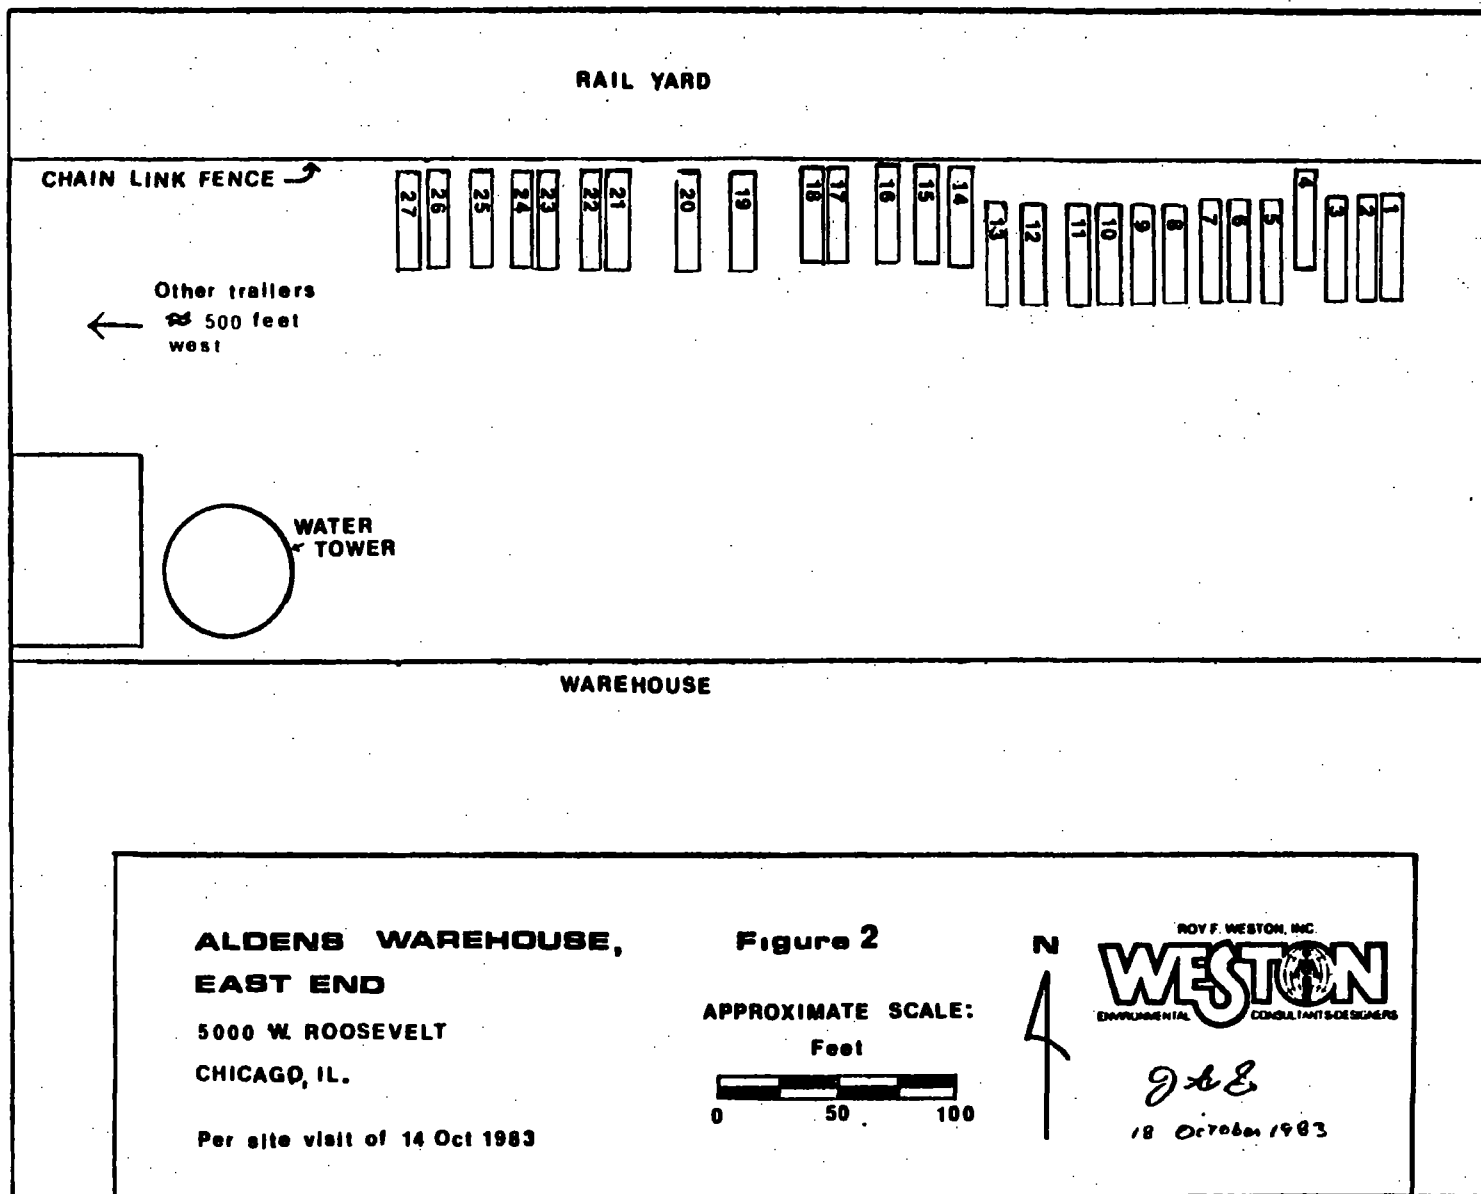
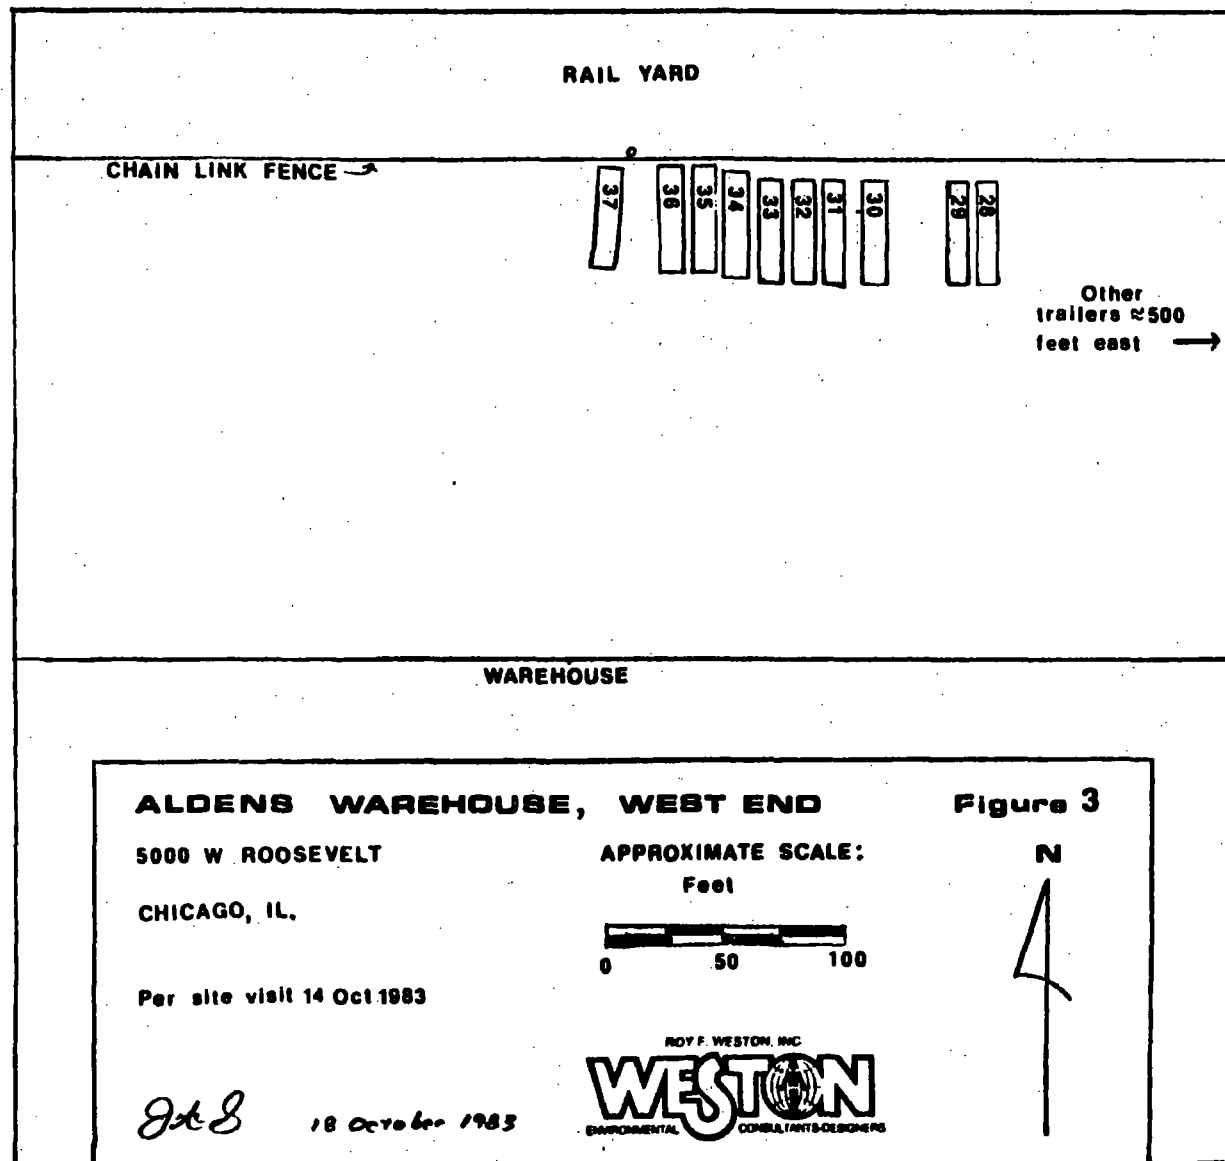
From the Rosemont site, the troopers and TAT proceeded to the abandoned Aldens warehouse site at 5000 W. Roosevelt, Chicago (Figures 2 and 3). Thirty-seven trailers containing chips were numbered with indelible markers. Twenty-seven of these trailers contain chips which were treated with sodium hypochlorite solution by Petrochem Services, Inc., during a state-funded Emergency Action this last summer. Recent analyses, however, have shown these chips still contain significant levels of cyanide and were included in the assessment. The results of the assessment are given in Table 2. Again, all the trailers showed signs of leakage or seepage of leachate (as the weather has been relatively dry prior to the site visits, most of the trailers at this and the Rosemont site were not actively leaking, but showed definite signs of past leakage). The troopers recommended that ten trailers, numbers 2, 3, 5, 11, 17, 30, 32, 33, 34 and 35, should be off-loaded. The trailers are situated on a

large parking lot of several acres in size behind the abandoned warehouse. No access or congestion problems exist.

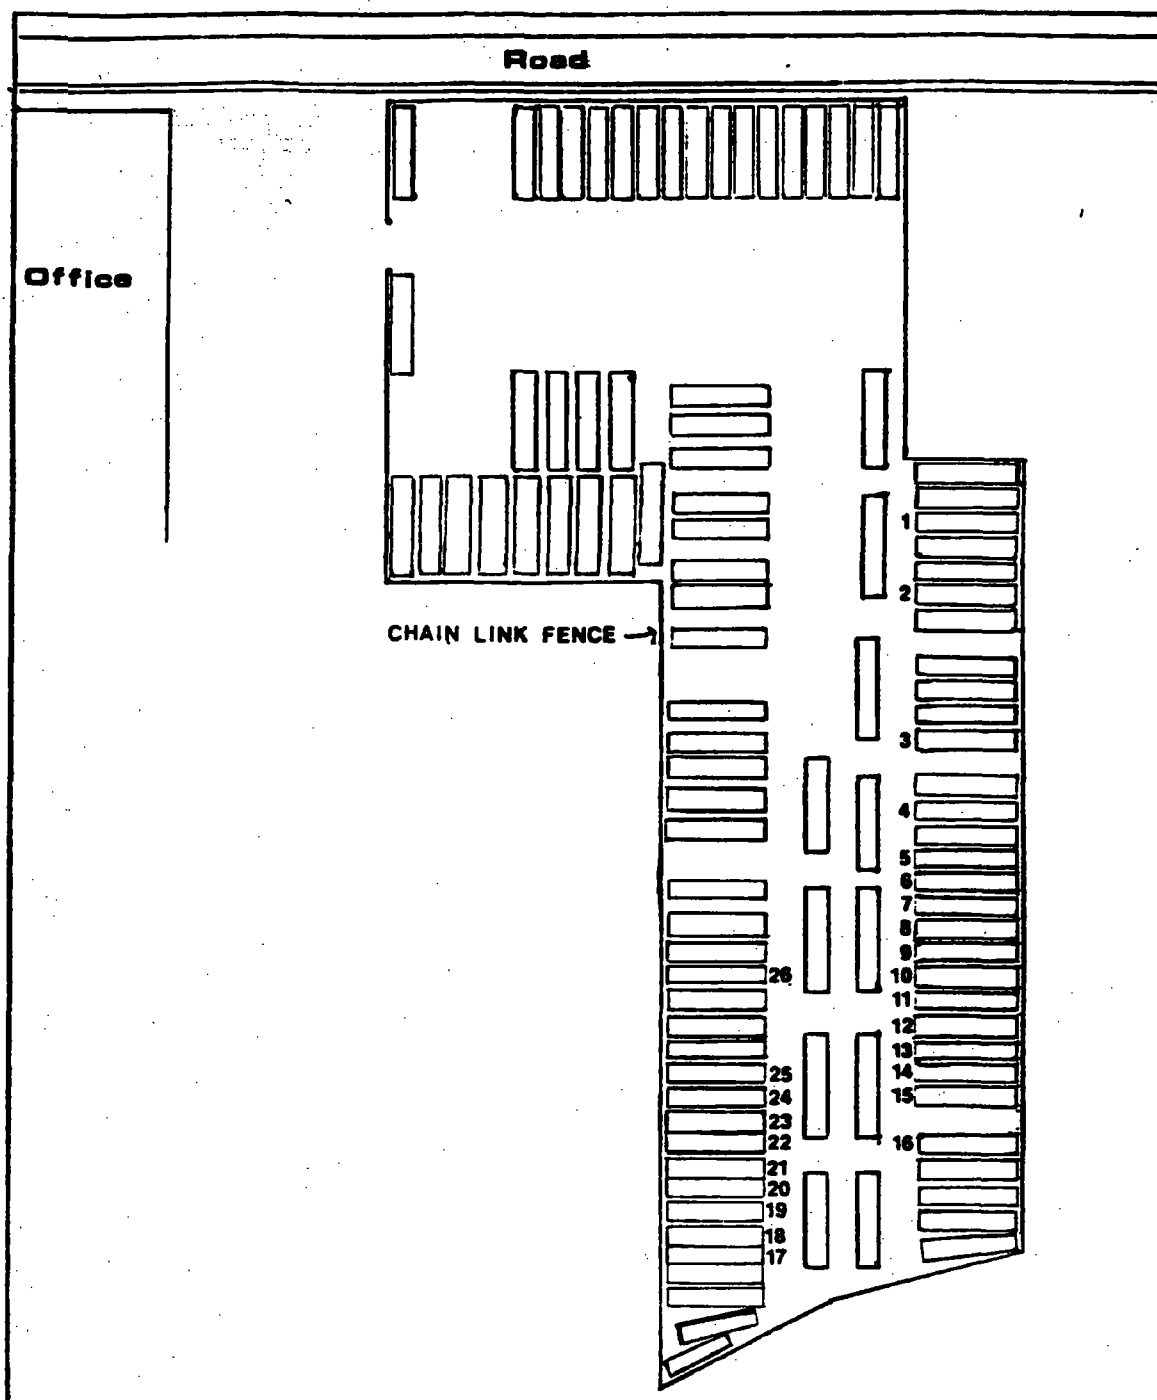
GEMINI LEASING (RITE-WAY) Figure 4

On 17 October 1983, TAT member Stofferahn met with Sargent Underwood and Troopers Zipsie and Patterson from District Four State Police Headquarters (13863 S. Cicero, Crestwood, Illinois) at the Gemini Leasing yard, 6021 S. East Avenue, Hodgkins, Illinois (Figure 4). The Gemini Leasing yard is an active facility. Twenty-six trailers containing waste chips located here were numbered with indelible markers. The results of the assessment of these trailers are given in Table 3. Most of the trailers were leaking; some were without jack stands. Nine trailers, numbers 11, 12, 14, 17, 19, 22, 23, 25 and 26, were recommended for offloading by the troopers. While gaining access to the twenty-six trailers will require only a minimal amount of movement of other units on the yard, acquiring room for repairs and offloading will be a problem due to the fact that this is an active place of business. The owner of the yard, who TAT met briefly during the site visit, complained that the waste trailers were taking up space on his yard which he could be utilizing for paying customers. The addition of ten more trailers, or several roll-off boxes, to store the chips from the ten unsound units is not anticipated to elicit a favorable response from Gemini officials.

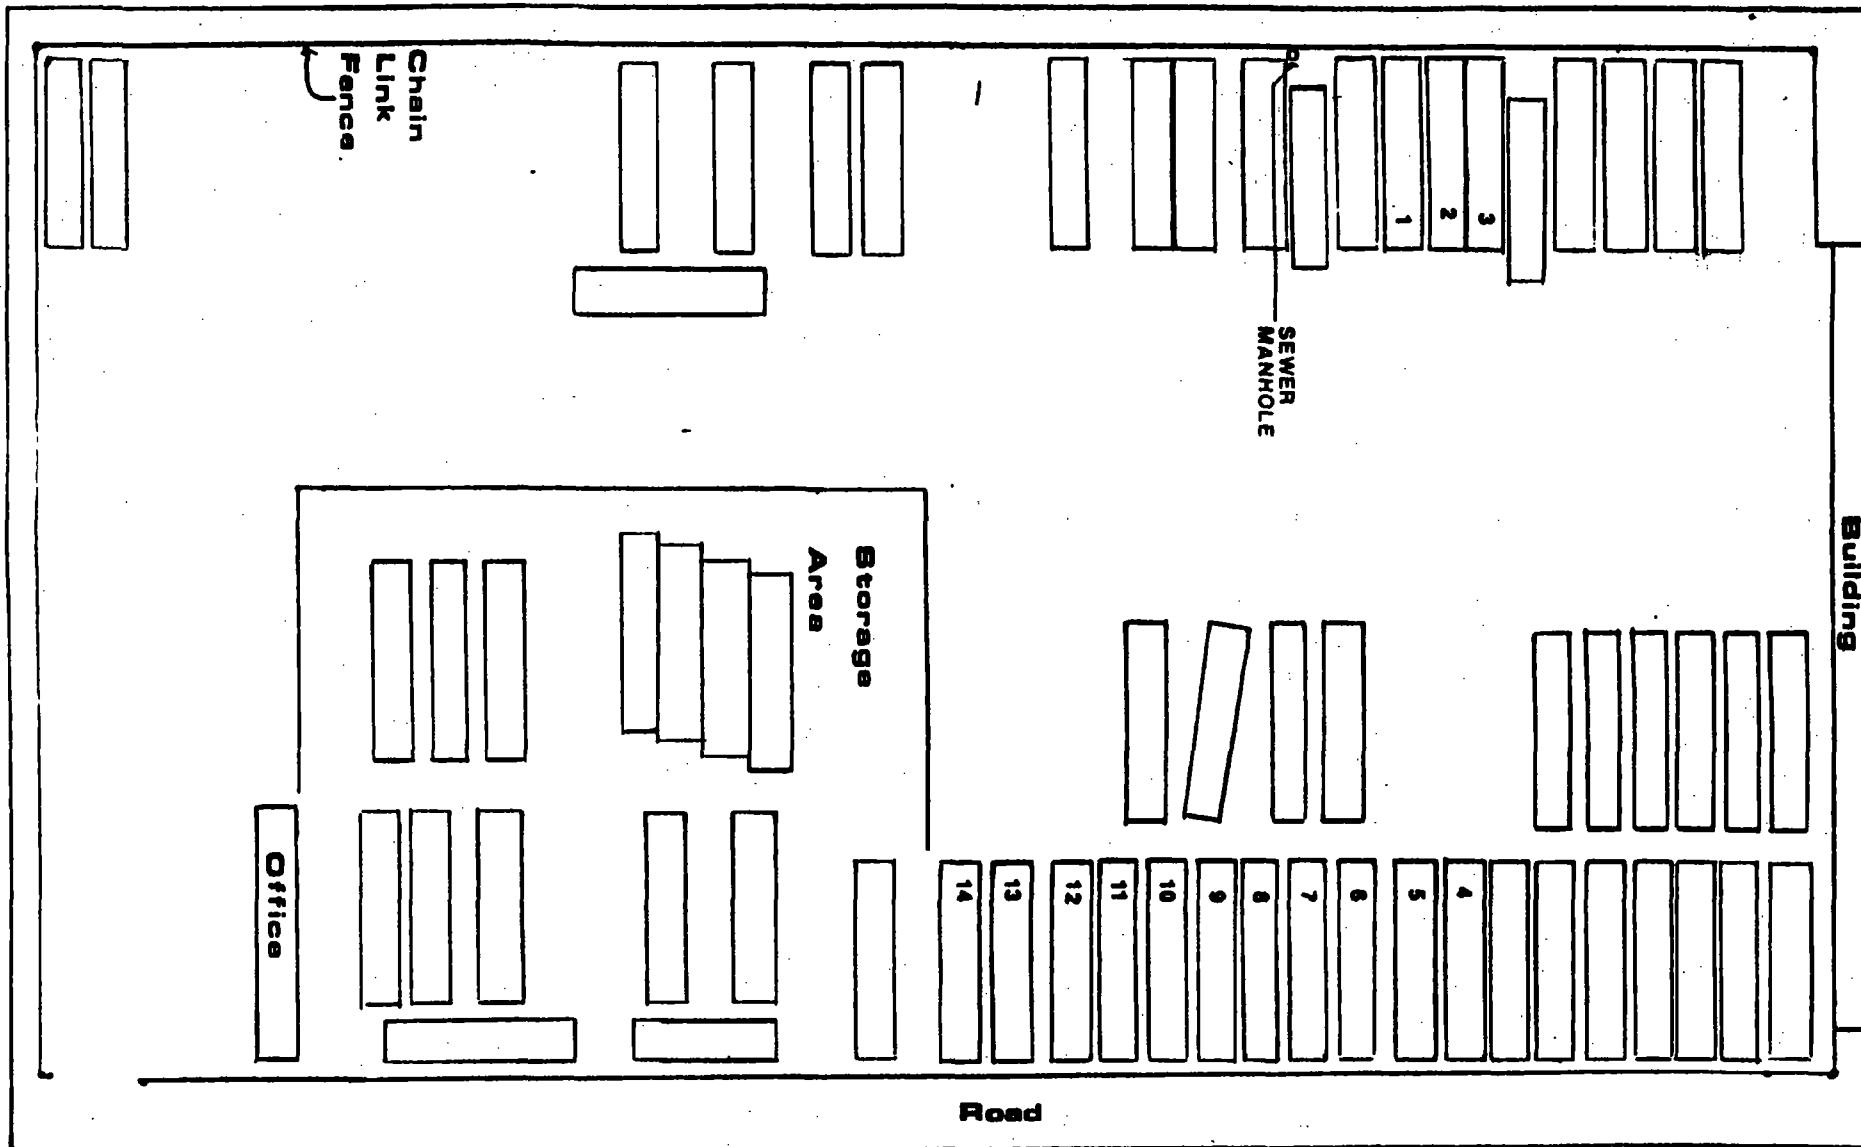
Figure 5

The next site assessed was J's Mobile Semi-Trailer Repair yard at 8765 W. Joliet Road, McCook, Illinois (Figure 5). Fourteen trailers located here were numbered and assessed. The results of the assessment are given in Table 4. Leakage of leachate from these trailers had been found to be migrating off site via a storm sewer by personnel from the Metropolitan Sanitary District of Greater Chicago (MSD) in September of 1983. Four trailers, numbers 1, 3, 6 and 7, were recommended to be offloaded. As with the Gemini Leasing yard, this is an active trailer yard. Access to the waste trailers is not anticipated to be a serious problem; however, finding enough room for repairs and offloading is.

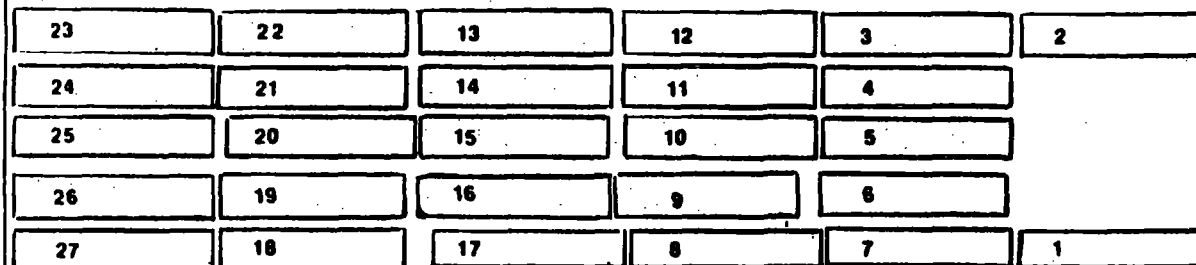
EAGLE TRAILER INC. Figure 6

The Eagles Trailer yard at 7710 W. 57th Street, Summit, Illinois (Figure 6), was the next site visited. Twenty-seven trailers containing waste were numbered and assessed. The results of the assessment are given in Table 5. As with the J's site, off-site migration of cyanide via a drainage ditch along the southern parameter of the site was documented by the MSD last September. Three units, numbers 2, 4 and 16, were recommended for off-loading. A considerable access and congestion problem was noted at this site. There is a totally inadequate amount of space within the area where the trailers are parked for any amount of work to be done. The trailer repair yard to the north is active, and cannot be used. The paved area leading to Archer Avenue could be used for temporary storage of sound units. To the northeast, TAT noticed a very large paved parking lot and what appeared to be abandoned buildings. This lot could also potentially be utilized for temporary storage or working space. An Eagle's employee stated this facility was owned by Ryder P.I.E., and supplied TAT with a business card for a contact with the firm (Attachment 1).

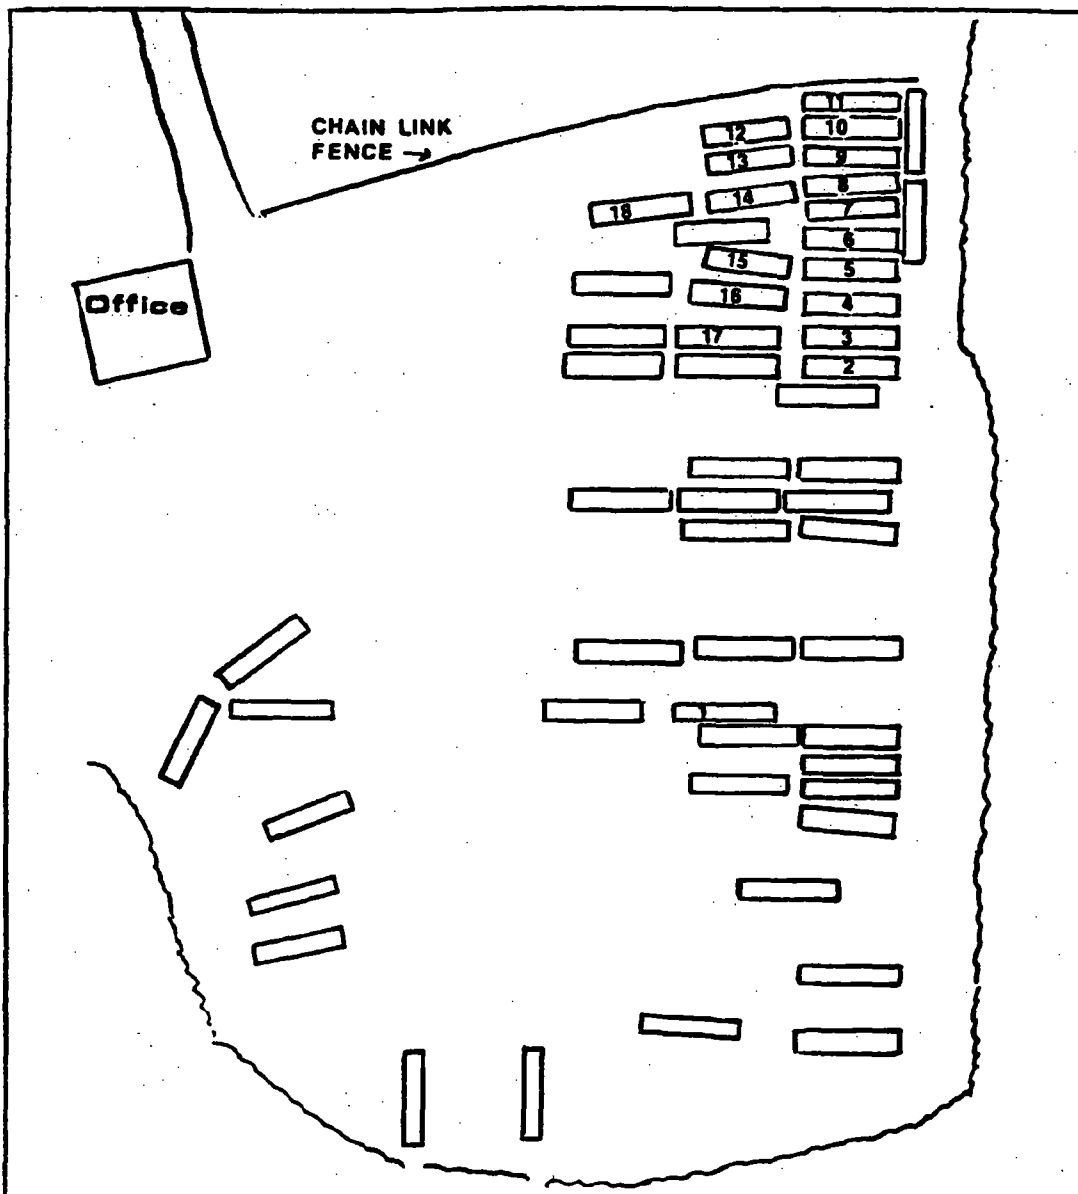
Figure 7

The Livco trailer yard at 6700 W. 130rd Street, Chicago Ridge, Illinois, (Figure 7), was the last site visited. Eighteen trailers containing waste were numbered and inspected at this facility. Table 6 provides the results of this assessment. All the units were leaking or seeping leachate, but only one, number 55, was recommended for offloading. While this is also an active facility, no significant access or congestion problems are anticipated.
